# SOCORRO

## A HISTORIC SURVEY

John P. Conron  
with the assistance of Anthony Alofsin

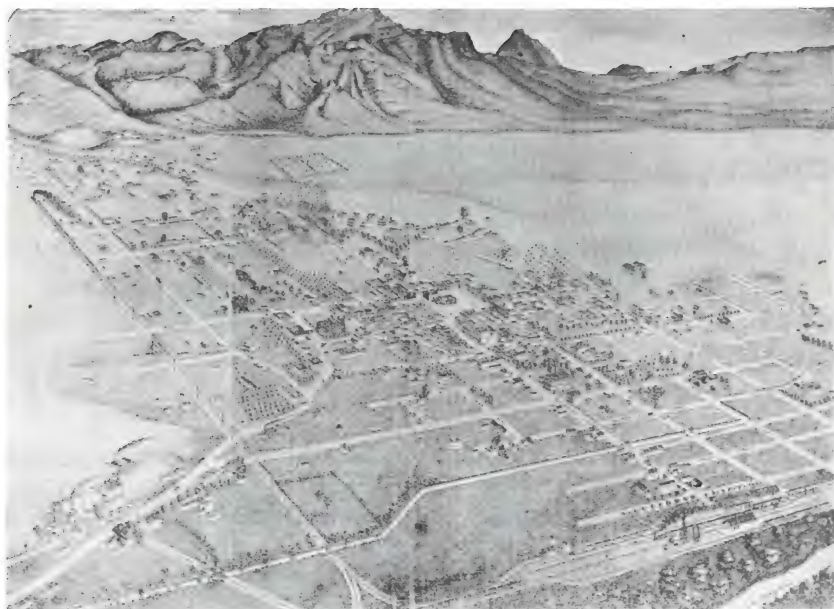
*Fig. 1 Bird's-eye view of Socorro, ca. late 1880s. Here is Socorro at the peak of the boom; a train heads west to Magdalena to pick up ore; the stamp mill is operating; a train sits puffing at the depot; and a number of historic properties, still standing today, are visible.*

Historic photographs from the early 1880s show the area of resettled Socorro as it had evolved since 1816 (Figures 1, 2, 3). The focus of village life, not only in Socorro but throughout colonial New Mexico, was the church. Stories persist, that the present Church of San Miguel (Map 2, site 15) was built on the ruins of the early mission and that Governor Manuel Armijo, last governor of the Mexican period, is buried beneath its floor. Archeological examinations have not completely confirmed these stories, but there are indications that the Church is sitting on and surrounded by the remains of an extensive pueblo.<sup>6</sup> The first book of records for baptisms, burials, and marriages dates from 1821, which is the year the Church was completed. The

View of Socorro" (see Figure 1). Two of the houses have attached store structures projecting as L's toward the street. Both stores are now empty. The house at 609 Nicholas (Map 4, site 57) has a large barn or warehouse-type structure similarly projecting toward the street. This house and barn structure, along with its neighbor to the west at 611, show the greatest degree of deterioration. Neither has been cement stuccoed, and both have fragments of mud plaster still clinging to the otherwise exposed adobe brick walls. Parts of the roof are missing from 611; both can be renovated, however, and both are occupied at this time.

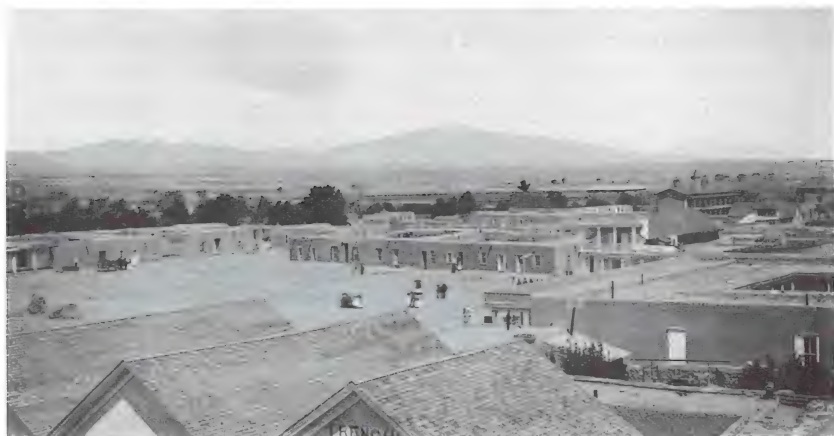
*Fig. 2 Looking northwest from the Masonic Building, 1882–83. The basic shape of the old Socorro Plaza is apparent here. Flat roofed buildings predominate. Arrow indicates the Delfine Zimmerly House, which would soon have a pitched roof added.*

transition from flat roof to pitched, as revealed in a pair of historic photographs taken shortly after each other. (see Figures 2 and 6). In Figure 2, the dwelling has a flat roof, while in the later photograph a pitched roof has been added—a forerunner of alterations to come to other structures. A similar pair of historic photographs shows the same transformation of the long series of adobe rooms, now called the White Row, at 300-306 Center Street (Map 3, site 23). From a flat roofed structure in one photograph, it is transformed, possibly by the following winter, into a pitched roof structure.

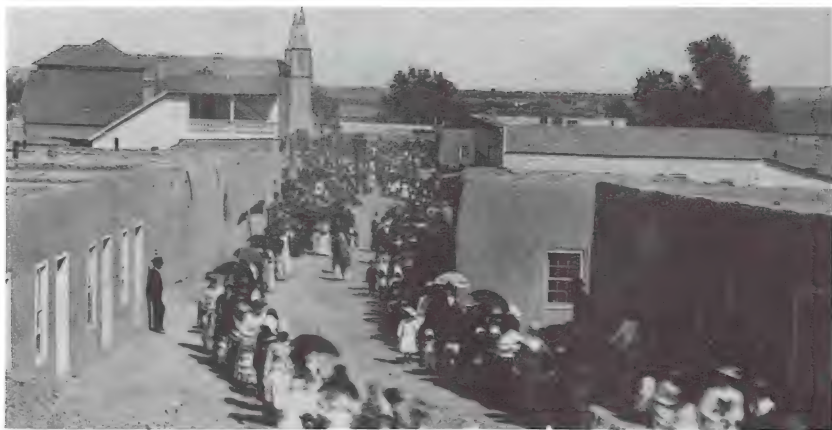
*Fig. 4 The San Miguel Parade (mid-1880s) is proceeding down Bernard Street towards San Miguel Church. The San Miguel celebration in Socorro coincided with Fiesta in Socorro, an annual festival occurring in many New Mexico towns. This typical streetscape demonstrates the nonaligned arrangement of buildings.*

These early structures built near the Church represent the traditional, Pueblo/Spanish New Mexico architecture (Figure 4). They had thick walls of adobe; the word *adobe* is from Arabic and means sun dried brick. Their earth roofs were flat, and they had exposed *vigas* (beams), whose ends occasionally protruded through the walls, with *latias* (whole or split tree branches) laid between the *vigas* in horizontal or herringbone patterns, and small windows and door openings set deeply in the walls in asymmetrical arrangements without wood trim. These buildings were an adaptation to the lack of milled lumber, and the

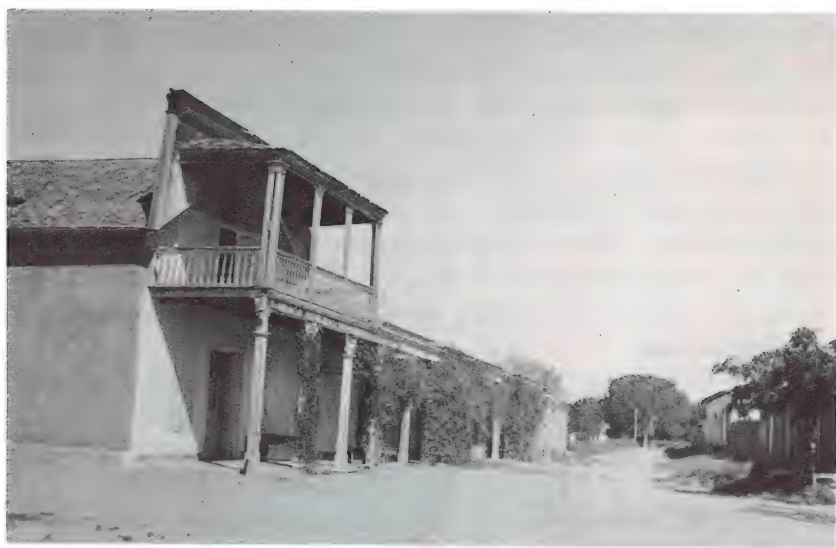
*Fig. 5 Juan José Baca store and house, ca. 1917. Today the basic structure is still intact though in need of maintenance. The lack of visible activity and sleepy feeling of this photograph attest to the decline Socorro experienced for the first three decades of the twentieth century.*

In the early Spanish/Mexican period, commercial stores were not separate entities. Business was conducted in a room of the house; eventually, some of these rooms became stores. The Juan José Baca store and residence (Map 2, site 2), the principal example of this development, has an elaborate overhanging balcony. In the late nineteenth century, it also had a wood false front, (Figure 5). This tradition was continued in the Chihuahua Historic District, where the Alvarez-Briggs House (Map 4, site 55) and 605 Nicholas (Map 4, site 56) though built in the late 1880s, had rooms utilized as stores. Also, facing Kittrel Park (Map 3, site 43) is the Fortune Property (Map 3, site 35), which contains rooms that were used as the post office and a general store.

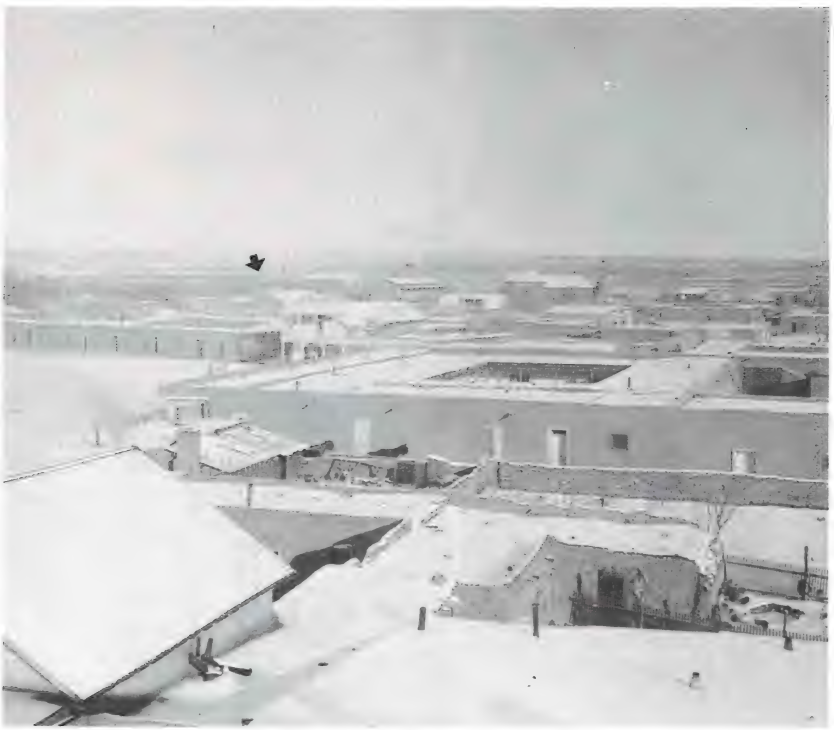
*Fig. 6 Looking northwest from the top of the Masonic Building (Abeytia Block), ca. mid-1880s. Arrow indicates Delfine Zimmerly House (11) which has been altered by the addition of a pitched roof. Flat roofs still predominate probably in the area of resettlement around San Miguel Church. The Pueblo/ Spanish floor plan utilizing placitas, enclosed courtyards, is apparent in the Garcia House, center of photograph, as well as in a number of other dwellings.*

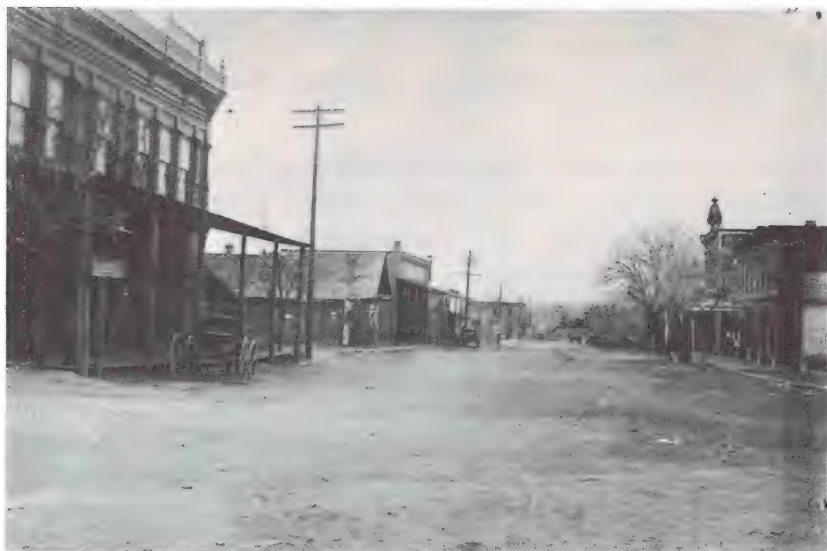
*Fig. 7 View east on Manzanares Avenue ca. late 1880s. The elaborate cornice of the Rio Grande Supply (28) is visible at left. Farther down the street on the same side is the Price/Loewenstein Mercantile (32) with a shed-roofed porch. The Knights of Pythias still retains its fancy parapet (30).*

Another innovative use of metal construction materials during the Territorial period was the advent of metal cornices and metal facing. The Sanborn Fire Insurance maps indicate “metal cornices” on many buildings; quite possibly, however, and considering the nature of many of these structures, these cornices may have been simple metal parapets. The Sanborn investigators perhaps found them noteworthy for their presumed qualities of fire protection. Galvanized cast iron (iron coated with zinc) may have been used in conjunction with pressed sheet metal, particularly on the cornice of the Rio Grande Supply (Map 3, site 28; also Figure 7). These cornices and metal facing materials were available by order from catalogues.

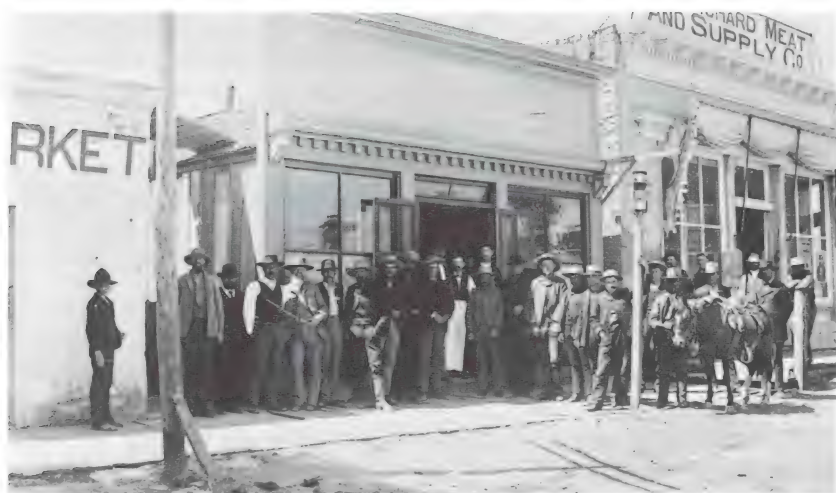
*Fig. 8 Southwest corner of the Plaza, ca. late 1880s. Apparently all of the imbibers from the saloon situated between two meat markets have poured onto the street to have their picture taken. The Blanchard Meat and Supply Co. is part of the Fortune Property (35) and seen here with wood front (over adobe bricks).*

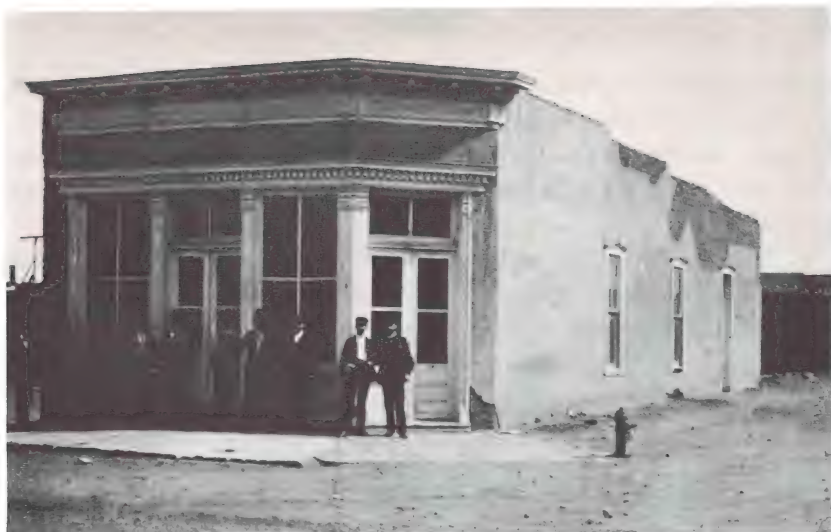
*Fig. 9 Structure at southeast corner of Manzanares Avenue and California Street, no date. The front facade is wood details over adobe bricks. The side facade, deteriorating, is plaster over adobe painted to resemble limestone.*

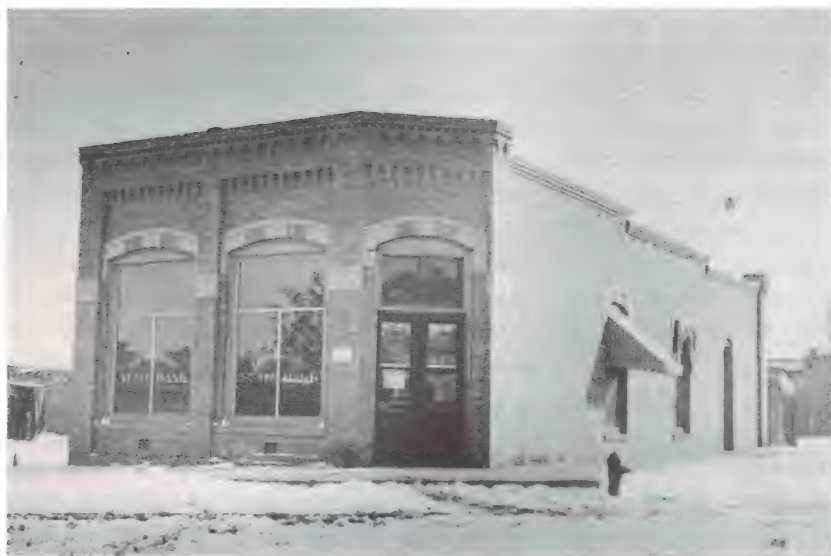
*Fig. 10 Structure at southeast corner of Manzanares Avenue and California Street, no date. In the remodeling, the wood front has been removed and the entire structure covered with a brick facade. Such transformations occurred frequently in Socorro.*

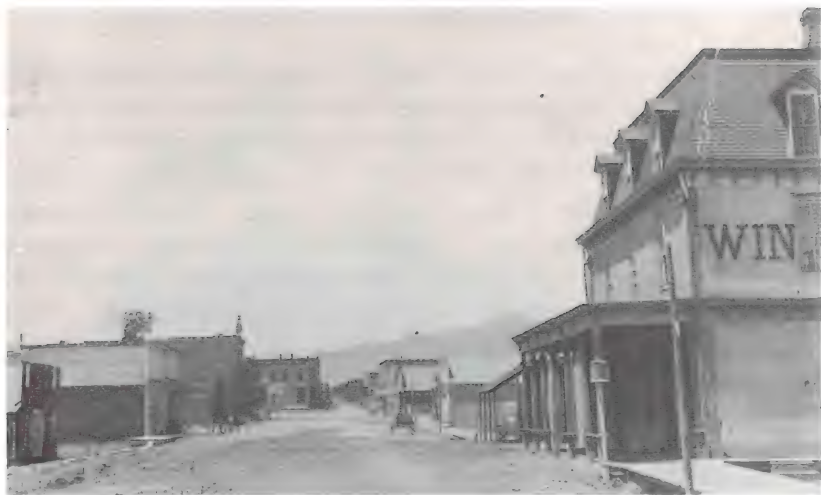
*Fig. 11 Looking west up Manzanares Avenue, no date. The Windsor Hotel is at the right; its eastern facade is plastered and painted to resemble limestone. A pair of wood-fronted structures were to become the Shakespeare Building (31). Also visible is the Knights of Pythias Hall with its free-standing parapet (30). The two-story Sperling Mercantile, across the street, is still standing.*

Other commercial structures had wood facades typical of the Victorian-era influence found in boom towns throughout the West: wood cornices, brackets, raised paneled-pilasters, and jigsaw work. In addition to the corner store of the Fortune Property (Map 3, site 35), the building at 102 Manzanares Avenue E. (Map 3, site 29) had such a facade. The three, pitched roof structures that were to become the Stapleton Brothers Mercantile (Map 3, site 41) exemplified the “wild west” style in combination with Territorial details in its *portal* and possibly in the treatment of its windows and doors.

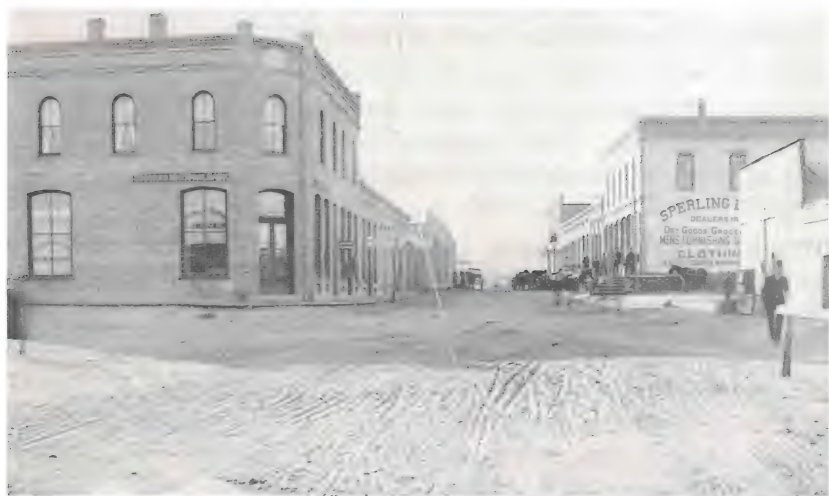
*Fig. 12 View looking west up Manzanares Avenue, between 1886 and 1898. The brick facades created an obvious architectural integrity along this central commercial block in Socorro.*

manufactured in Socorro at the Fire Clay Works—an entire generation of brick commercial buildings was constructed beginning in the early 1890s. Historic photographs reveal that they had corbel tables, arched windows that were often narrow in width and long, recessed panels, and dentillated coping.

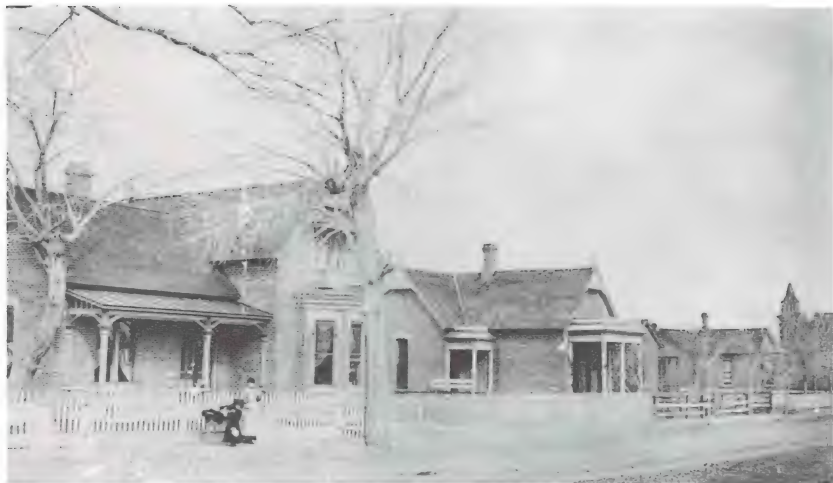
*Fig. 13 North side of McCutcheon Avenue, ca. 1905. This row of brick cottages provides an exemplary visual integrity. At the far right in the background is the tower of the county courthouse constructed in 1884. From right to left we see the Capt. Cooney House (64), the Fitch House (65), the Eaton/Darr House (66), and the house of W. E. Griffith.*

The series of brick cottages constructed along the north side of McCutcheon Avenue contains combinations of Italianate and Queen Anne details (see Figure 13). The Captain Cooney House (Map 4, site 64) best retains its original features: its arched windows and bay and its wooden porch. The Cortesy House (Map 2, site 14) has had minor alterations while the Eaton/Darr House (Map 4, site 66) has unfortunately undergone major alterations to its facades. The Fitch House (Map 4,

site 65), although painted, retains much of its detail and is unique for its neo-classic columns, which became popular toward the end of the century in the World's Fair Classic style popularized at the Chicago World's Fair in 1893.

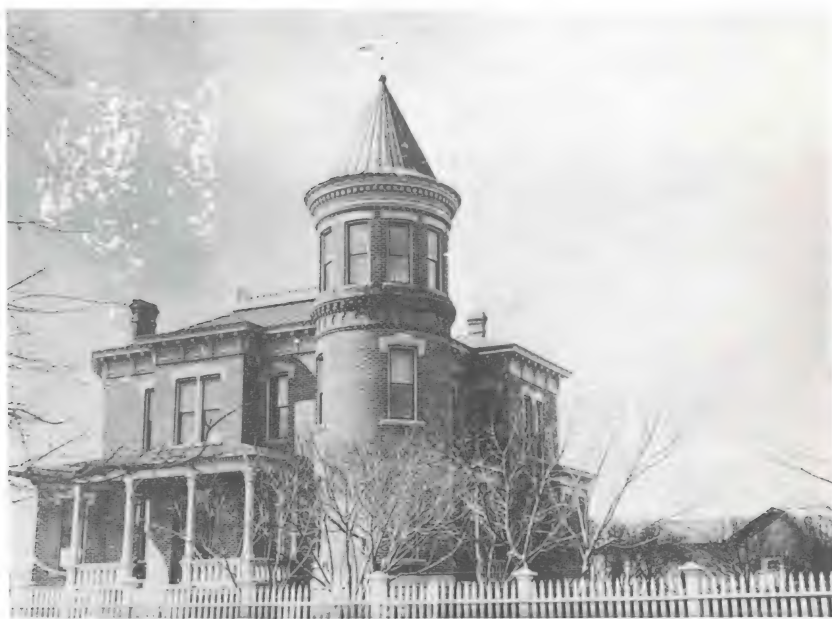
*Fig. 14 Casa de Flecha. Residence of F. G. Bartlett, ca. 1905. Bartlett, like many of his contemporaries, came to seek his fortune in New Mexico and found it. In 1883 he established a general store in Magdalena where he organized the First National Bank of Magdalena. His business interests included a sawmill and sheep and cattle ranching, and he also established the Ranch Supply Co. of Magdalena.*

The brick Abeytia y Armijo House on Park Street (Map 4, site 68), is known as the *Casa de Flecha*, or House of the Arrow, because of the arrow-shaped weathervane atop its turret. Located within the Church/McCutcheon Historic District, it is an outstanding example of Queen Anne style architecture (see Figure 14).

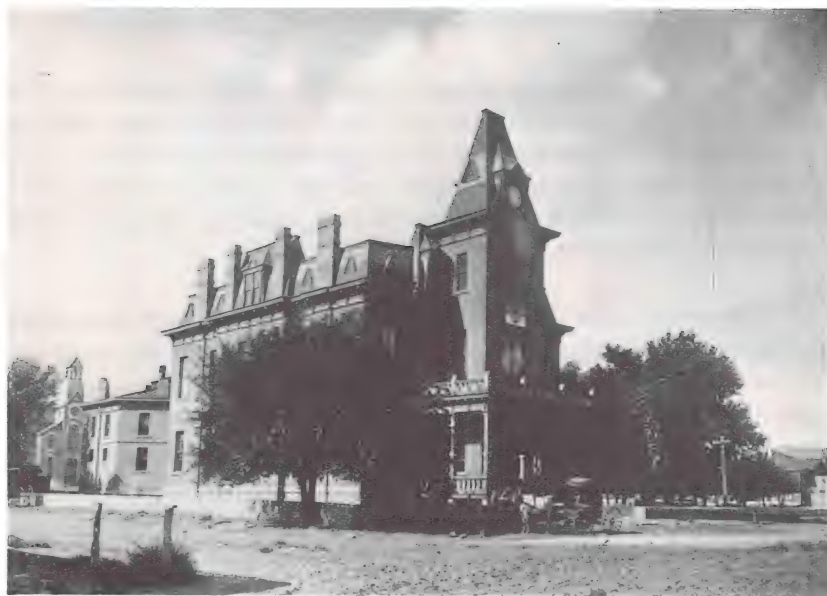
*Fig. 15 County Courthouse, built in 1884. Photograph ca. 1907–10. To the rear of the Courthouse is the unusual octagonal brick jail and behind it the brick schoolhouse with tower. At the far right, partially obscured by trees, is the residence of Joseph E. Smith and family at 301–303 Park St. (70).*

These impressive brick structures, along with commercial buildings still there, formed a distinct architectural image in Socorro, once complemented by other structures that have been razed. Although the details vary, red brick was the principal medium of this era. The former County Courthouse, constructed in 1884, was a *tour de force* of High Victorian-era styling with its mansard roof, ornamental details, and connecting octagonal jail. Later, behind the Courthouse and Jail, a two-story brick schoolhouse, topped by Chateausque-style chimneys and fronted by a high bell tower, was built (see Figure 15). The nearby A. D. Coon House, another impressive two-story brick structure faced California Street; it burned in 1898 (see Figure 16).

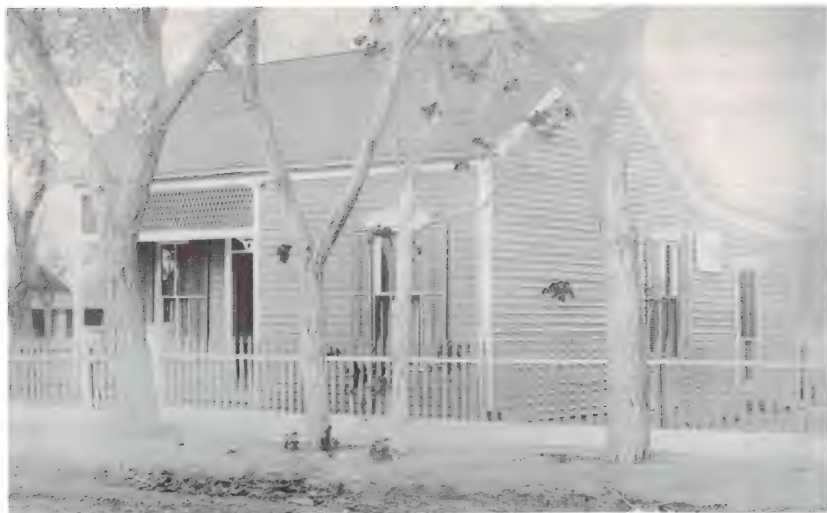
*Fig. 17 110 Sixth Street N., no date. The mate to its "twin" at 407 California Street N., (7) it differs only in the placement of the front porch, which is on the opposite site of the front facade in the California Street example.*

A further example of the direct influence of the Victorian era is found in the existence of identical houses in Socorro. The clapboard houses, replete with neo-classic details, at 407 California Street N. (Map 2, site 7) and 110 Sixth Street N. (Map 3, site 36) were either ordered from a catalog and shipped to Socorro in prefabricated sections, or they were copied from one of the pattern books that spread Victorian period styles throughout the country (see Figure 17). A third example of

this same house is found in Socorro at 319 Terry Avenue, although it has been stuccoed.

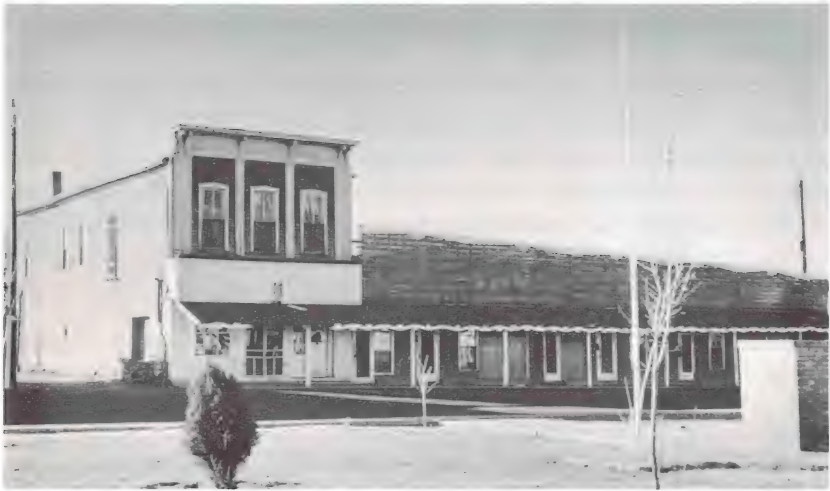
*Fig. 19 Sedillo House, before restoration. The second story, nineteenth century facade is intact. The ground floor has been slightly altered.*

period facade, the metal cornice of the Rio Grande Supply was removed, and the building drastically remodeled in the Mission Revival style. The former Price/Loewenstein Mercantile, now the Loma Theater (Map 3, site 32), likewise had a face-lifting in the Mission Revival style. Even into the 1970s the Mission Revival style has been used to replace authentic historic facades. In a disastrous remodeling, the Sedillo House along the west side of Court Plaza had its elaborate 1880s false front covered by heavy stuccoing and poorly proportioned arches loosely based on the Mission Revival style and scant knowledge of architectural history (see Figure 19 and 20).

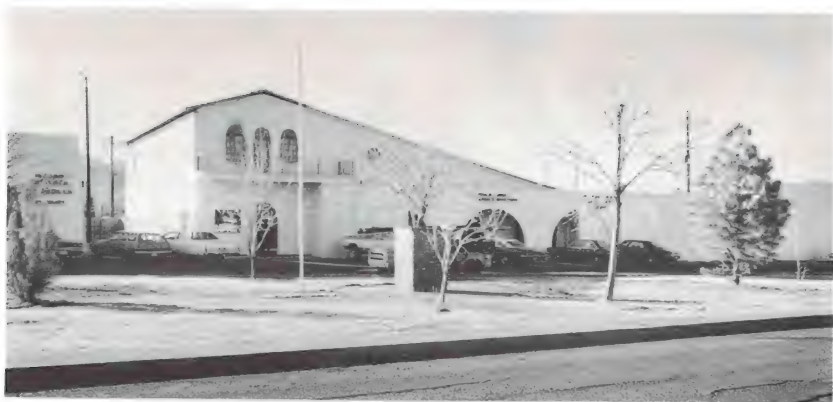
*Fig. 20 Sedillo House, after restoration.*

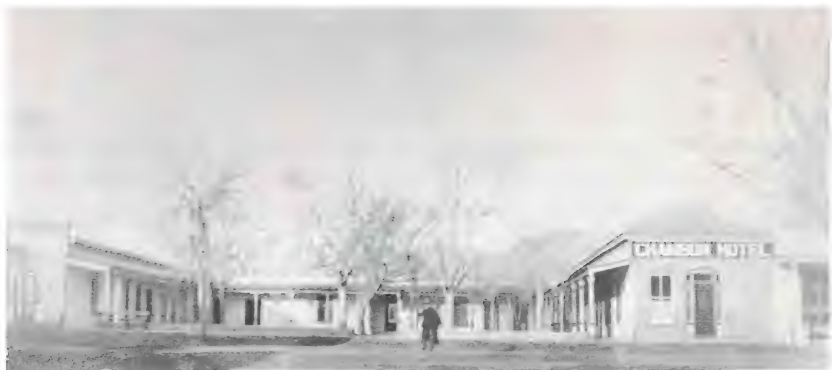
*Fig. 22 Park Hotel when this photograph was taken, the Chambon family owned the venerable hotel, which experienced several name changes. Note the extension of the arms of the U to the street line.*

commercial area grew, it expanded around Kittrel Park and east along Manzanares Avenue toward the Santa Fe Railway Depot. The tree covered park was once rather tightly enclosed with one-story commercial buildings; the Abeytia Block and its immediate predecessor were the only two-story commercial buildings facing the park during the late nineteenth century. The wide area into which Bernard Street opened on the north side of the park afforded the only broad opening from the park until a fire in 1886 destroyed several one-story buildings along the southern side (see Figure 21). Most of these stores were not rebuilt and eventually Court Plaza was created. Even with these arms extending to the north toward Bernard Street and to the south toward the County Counthouse, Kittrel Park remained a visually enclosed plaza. The two-story Fitch (Map 3, site 39), Crabtree (Map 3, site 40), and Ocean-to-Ocean Garage buildings were constructed after the turn of the century and replaced earlier structures. The demolition of the Park Hotel (Map 3, site 27)—which occupied a prominent place on the west side of the plaza (Figure 22)—and the adjoining Ocean-to-Ocean Ga-

U-shaped Park Hotel (see Figure 22) formerly fronted the park around a landscaped forecourt well defined by two flanking wings extending to the sidewalk line, one of which abutted the Gem Theater/Ocean-to-Ocean Garage building to the north. These buildings have been replaced by the 1960 Safeway/Fabric World building which sets far back from the former sidewalk line and is fronted by a sea of unbroken black asphalt. The enclosed plaza form has been destroyed on this, the west, side. The Safeway/Fabric World building itself is not at fault, but rather it is the placement of it upon the lot. The enclosed plaza form could have been retained by placing the parking lot behind the building rather than in front. Long range planning by the City must insist that any future construction on this key site be placed forward at the former sidewalk line; parking should be placed behind.

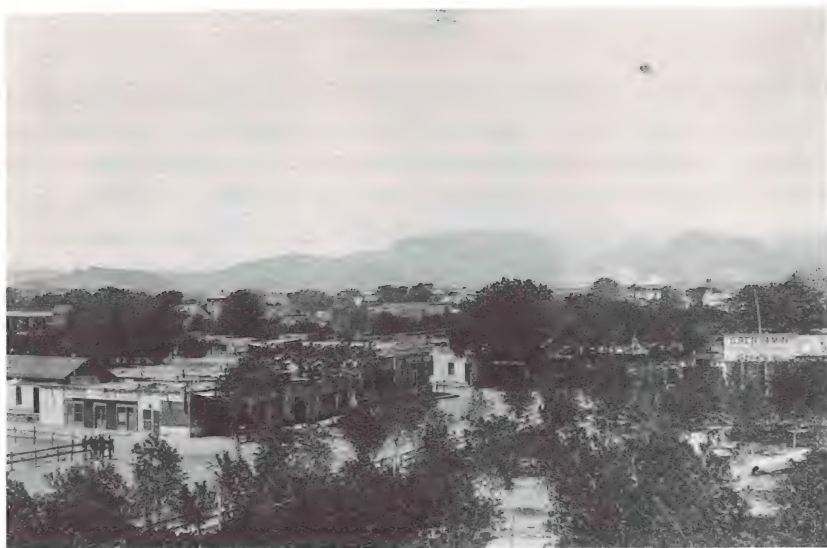
*Fig. 23 View to the southwest over Kittrel Park, no date. In the center of the photograph the Blanchard Meat and Supply Co. is visible. In the background smoke is seen from the Billing Smelter west of Socorro.*

Surrounding the park should be a revitalized business core for Socorro, while within the park the shade trees will give pleasant contrast to the commercial activities outside. The Fortune store (Map 3, site 29) can, and should, be restored to its past details (see Figures 8 and 23). The Capitol Saloon (Map 3, site 38) is another restorable building (see Figure 24). These two buildings have undergone the least structural alteration, and they should be restored to their documented facades.

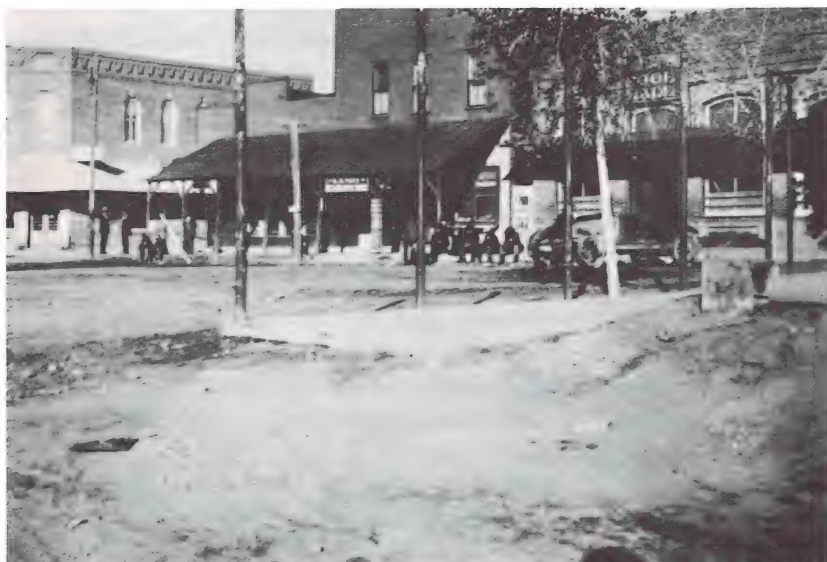
*Fig. 24 Capitol Saloon, no date, post-1912. The Pool Hall sign indicates the location of the Capitol Saloon, whose brick facade and large arched windows with cafe curtains give an indication of the building's former appearance.*
